INVESTIGATING ROCK MASS CONDITIONS AND  
IMPLICATIONS FOR TUNNELLING AND  
CONSTRUCTION OF THE AMETHYST HYDRO  
PROJECT, HARIHARI.

A Thesis

Master of Science in Engineering Geology

University of Canterbury

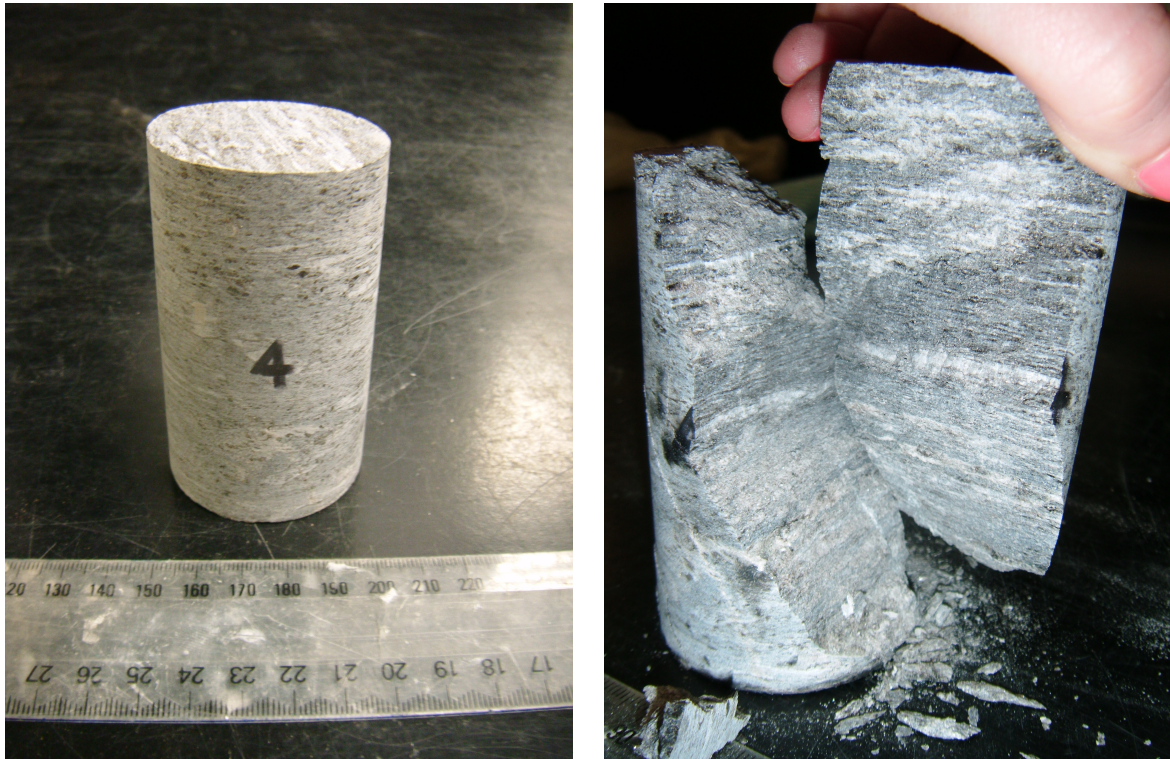
**Figure 2-7: Sample 4 prior to UCS testing (left) and after testing (right).**

Sample 4 failed at 67.8MPa, the highest value of all the samples. As with sample 2, it was cored with foliation perpendicular to loading direction, which resulted in a high compressive strength. The failure surface propagated through intact rock and through the whole length of the core. It was rough and unweathered, showing this is again representative of intact rock strength.

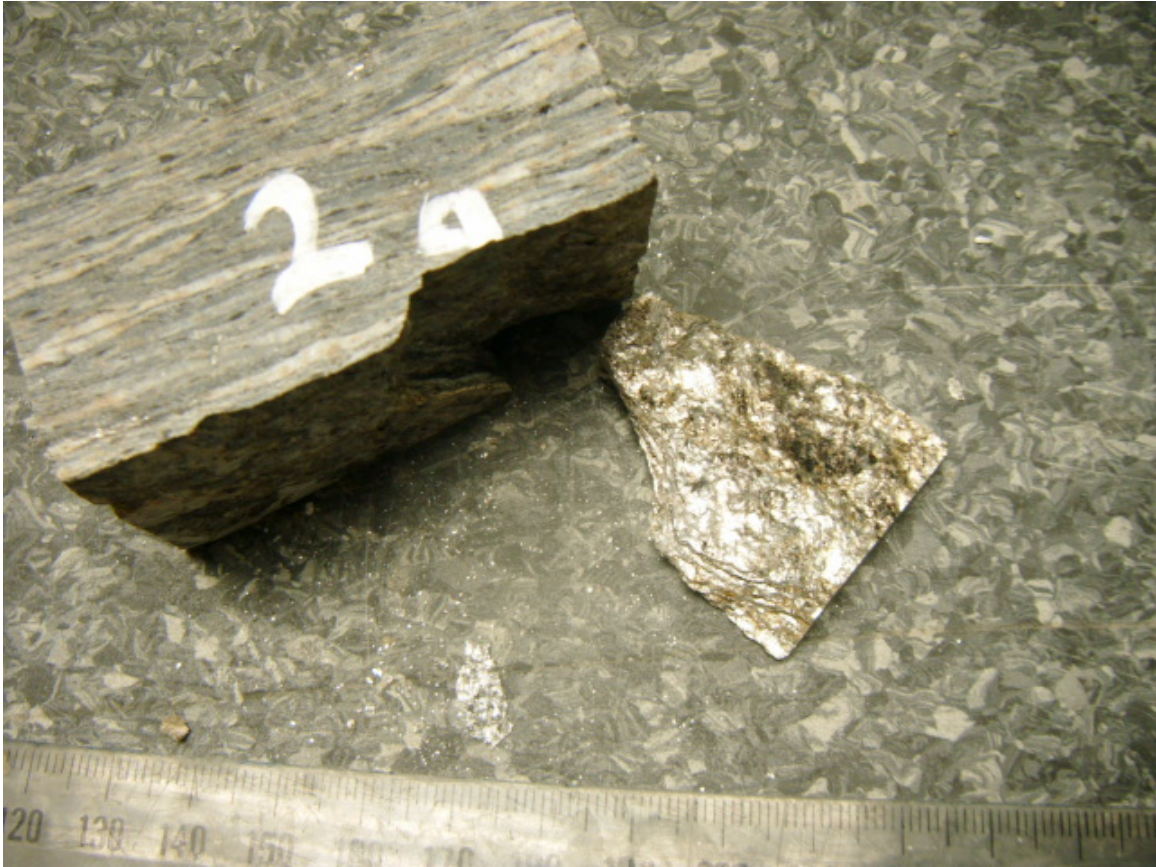
**Figure 2-8: Test 2a from sample 2, showing the invalid result caused by failure along foliation. No through-going failure plane was achieved.**

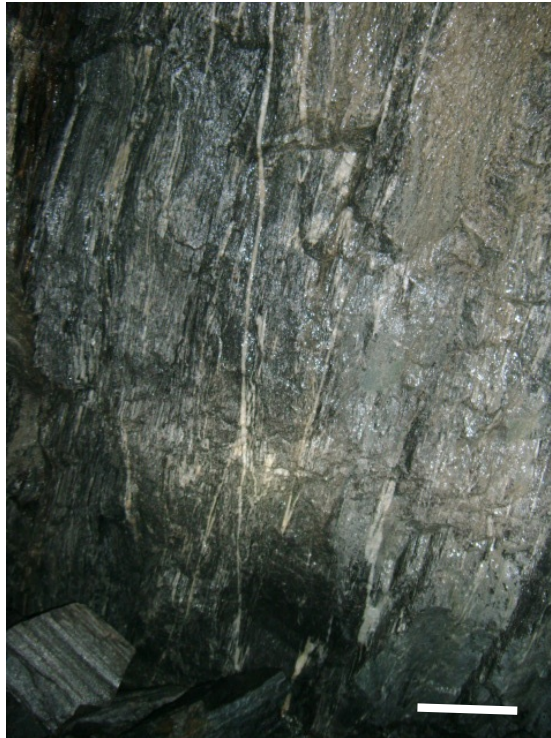
**Figure 3-1: Picture typical of the Alpine schist seen within the tunnel. Mineral banding (quartz, feldspar and biotite) is of both varying thickness and continuity throughout the tunnel. White scale bar is 300mm**

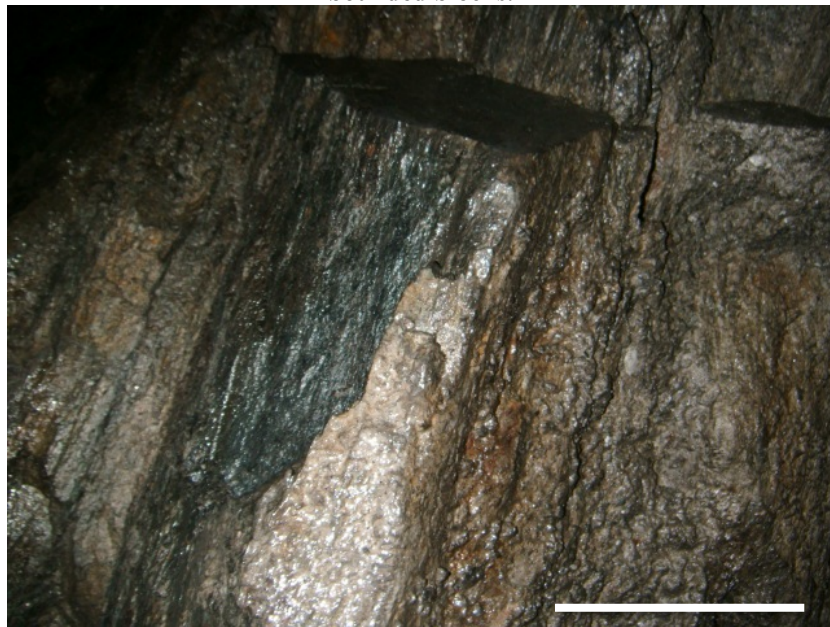
**Figure 4-10: Joint surface acting as a release surface for a schistosity bounded block. White line is 20cm.**

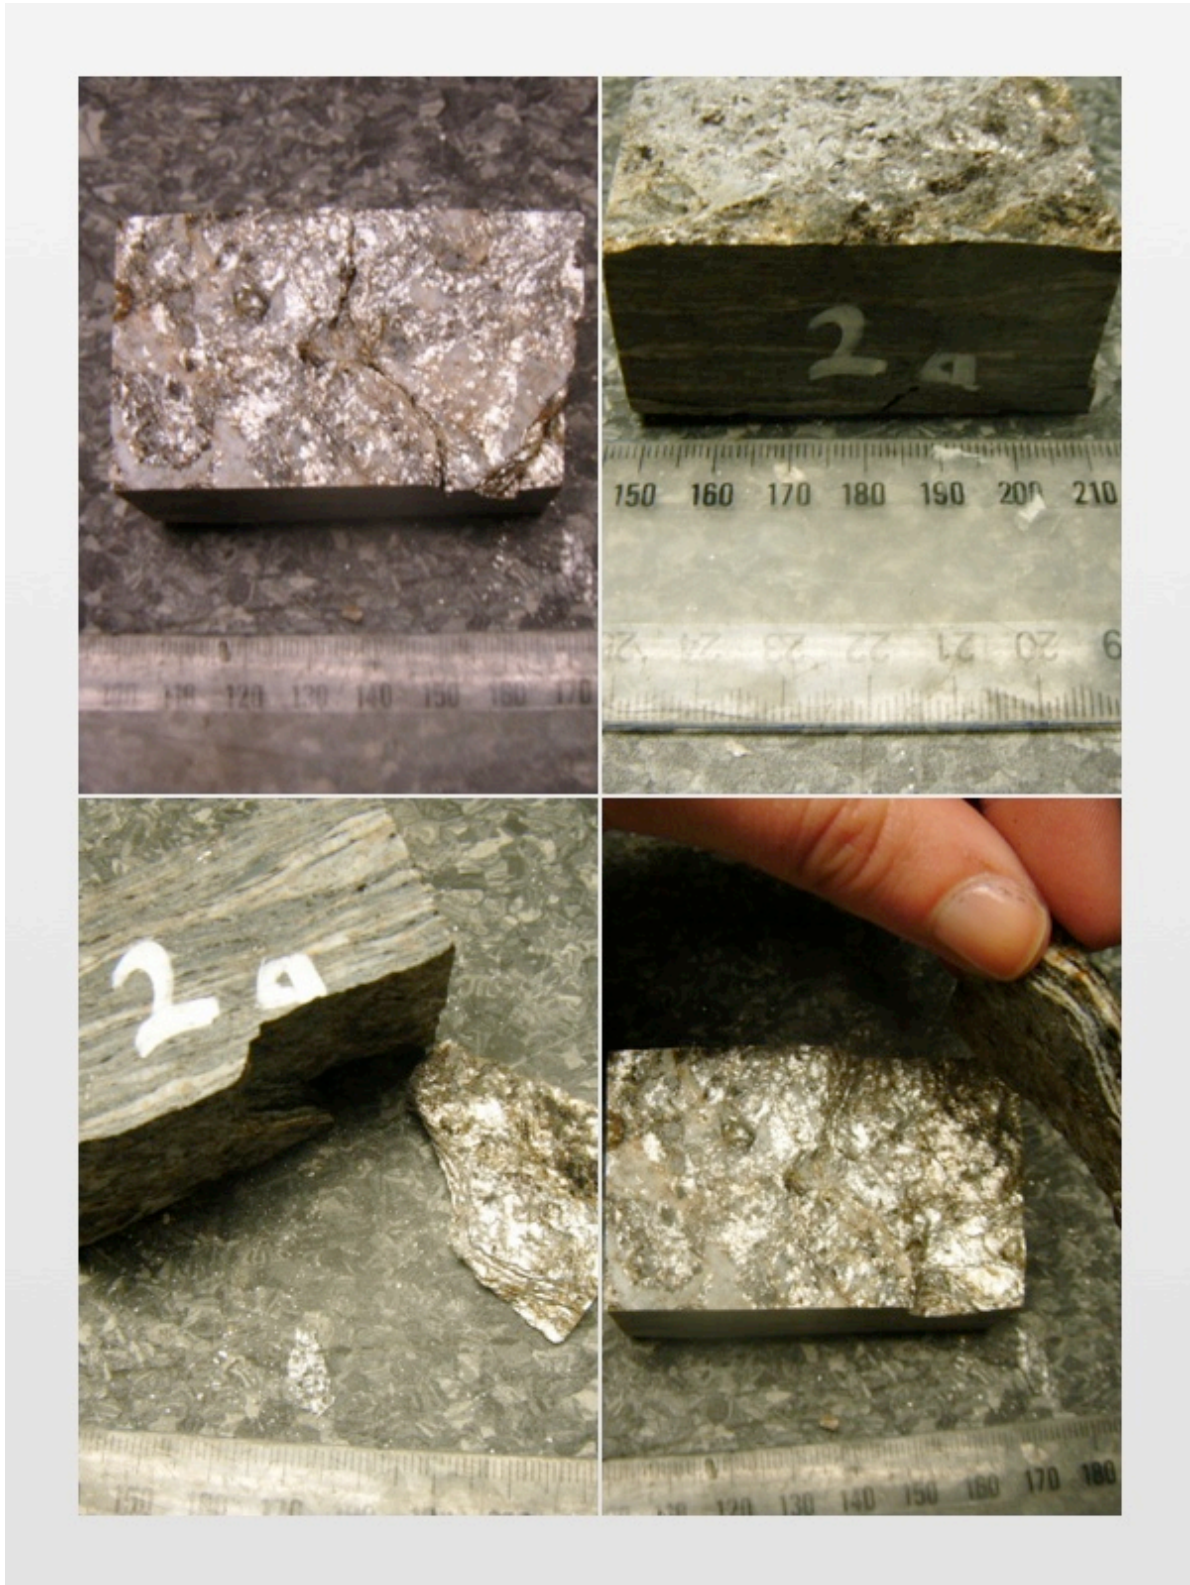
Figure C-8: Sample 2a after testing – test was invalid.

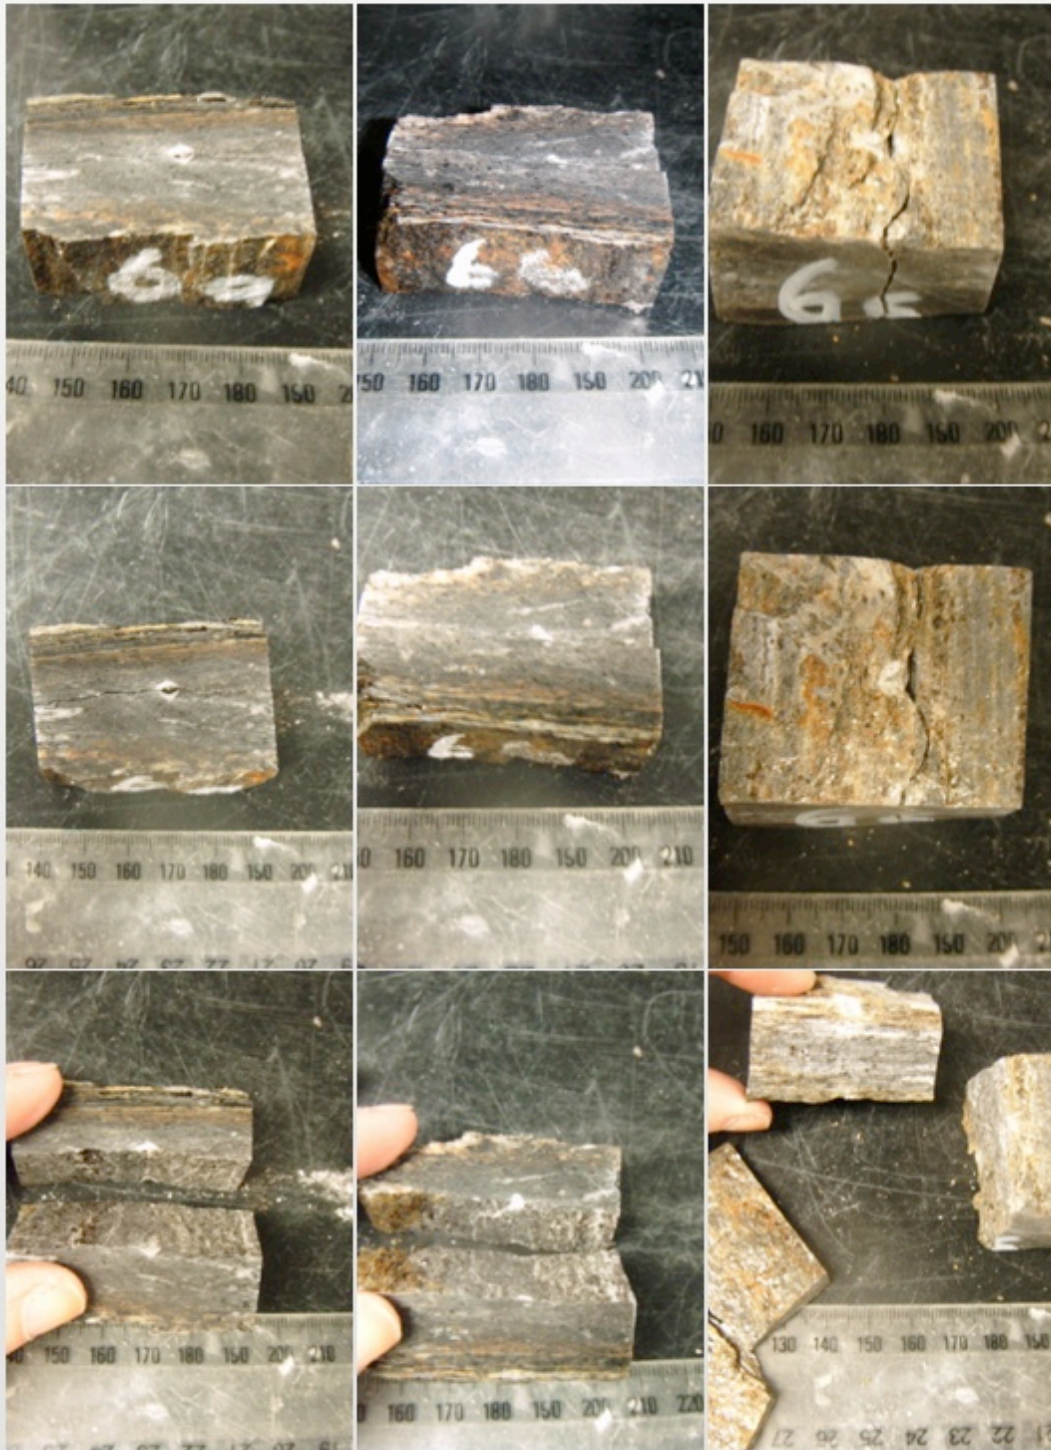
Figure C-11: Samples 6a, 6b and 6c after testing. Sample 6c was invalid.

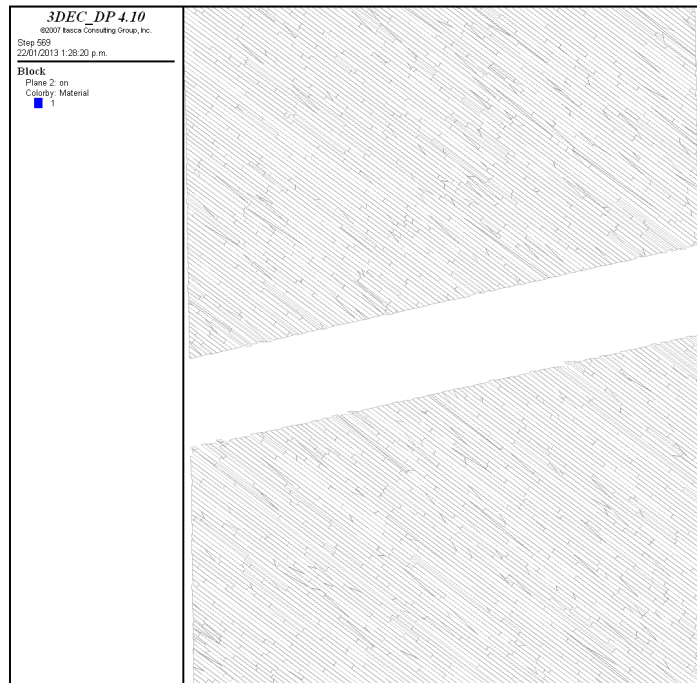
**Figure F-4: Domain 2 longitudinal cut away.**

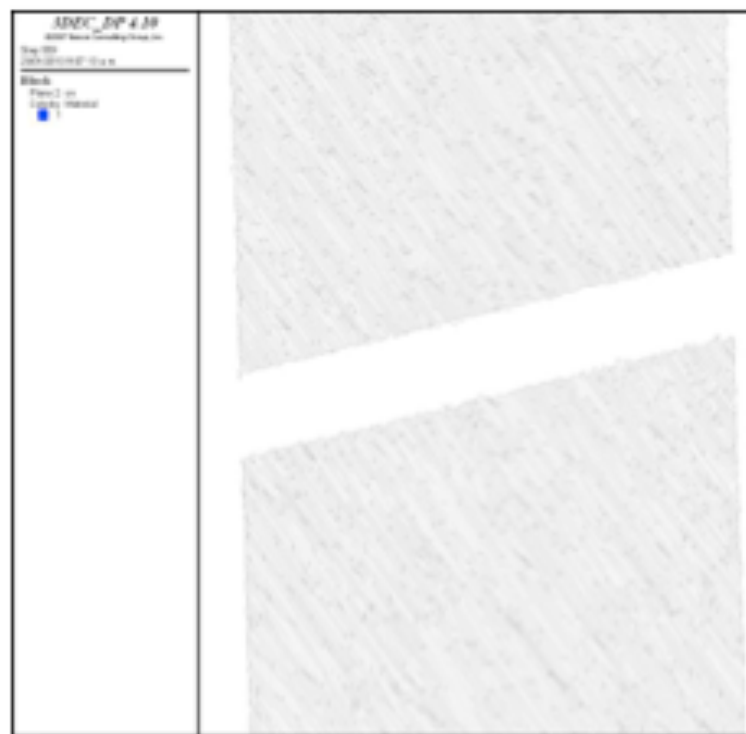
Figure F-24: Domain 4 longitudinal cut away.

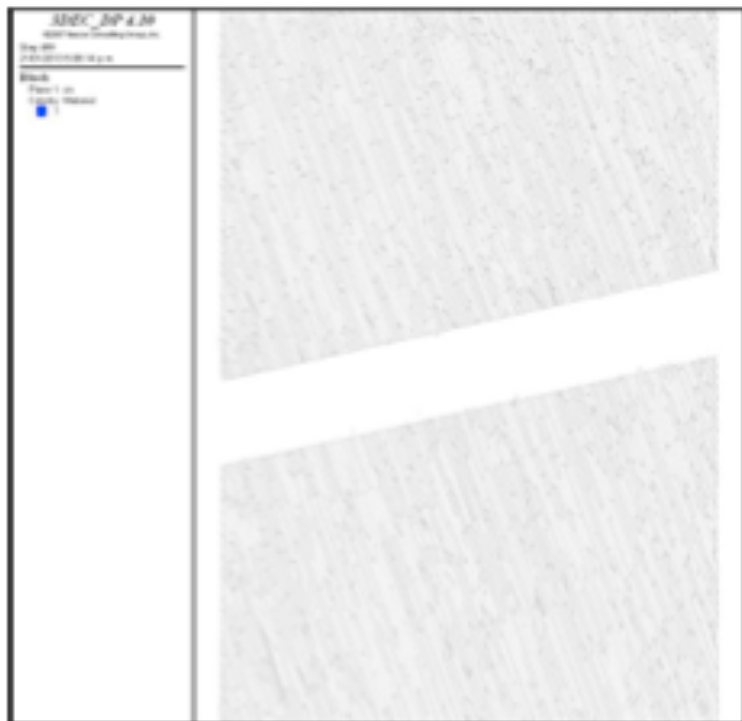
Figure F-34: Domain 5 longitudinal cut away.

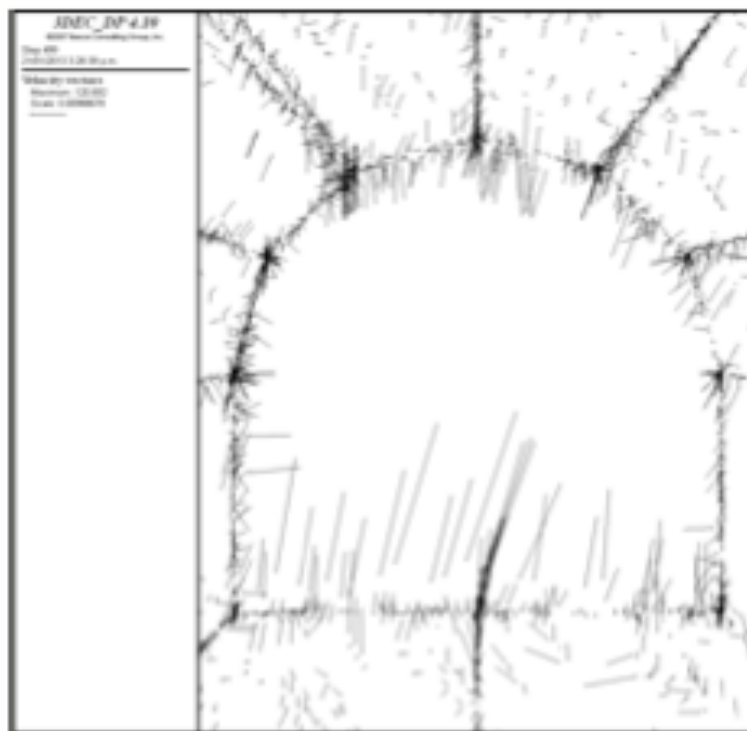
Figure F-38: Domain 5 velocity vectors.
